# NORTHERN PIPE, INC.

CLEAN - INSPECT - REPAIR

Measured from MH	Tap Location	Size	Material	Lateral Seg. Ref.	City
Upstream	248.1	4	Vitrified Clay Pipe	109 W. Bradley Rd	Village of Fox Point
Surveyed By	Certificate Number	Building Address	Street	Upstream MH	Downstream MH
Avery DeJardin	U-108-6266	109	W Bradley Rd	04-069	04-068
Direction	Purpose	Weather	Date	Time	Length Surveyed
Upstream	Maintenance Related	Light Rain	20180122	5:00 PM	5.8
<b>Additional Information</b>					
95' to house

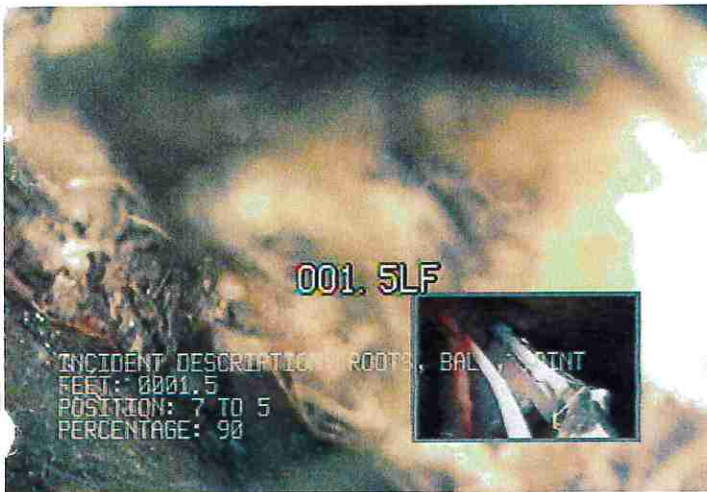
RBJ - Roots, Ball, Joint @ 1.5 ft.

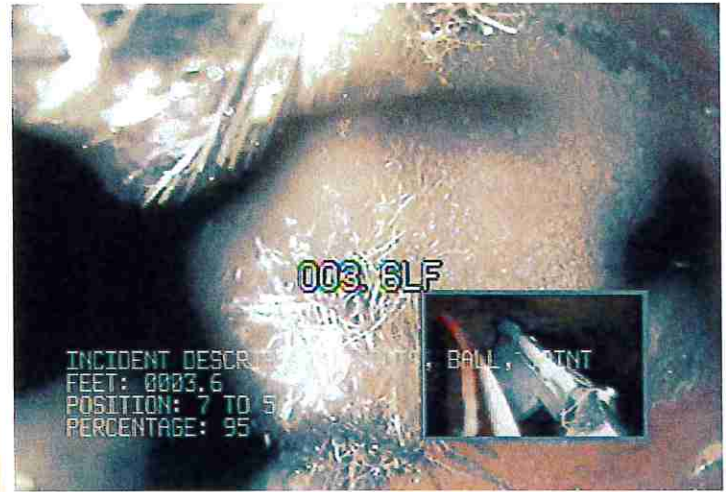
Camera will not pass heavy roots in lateral.  
 End Report

RBJ - Roots, Ball, Joint @ 3.6 ft.
