Surveyors name: Raul Lopez  
 Certificate Number: U-104-797  
 System Owner: Fox Point  
 Survey Customer: Fox Point  
 Drainage Area: N/A  
 Sheet: 1

P/O No.: N/A  
 Pipeline Segment Reference: 1  
 Date: 20130701  
 Time: 08:46  
 Location (Street Name and number): Spooner Rd  
 Locality: Fox Point

Upstream MH: 08-083; Downstream MH: 08-082; Size: 8; Total Length: ; City: Fox Point; Material: Vitrified Clay Pipe; Surveyor's Name: Raul Lopez; Certificate Number: U-104-797; Location Details: ; Street Address: Spooner Rd; Date: 7/1/13; Time: 9:46:00 AM; Length Surveyed: ; Purpose: Post Rehabilitation Survey; Direction: Downstream; Weather: Dry; Additional Information: ;

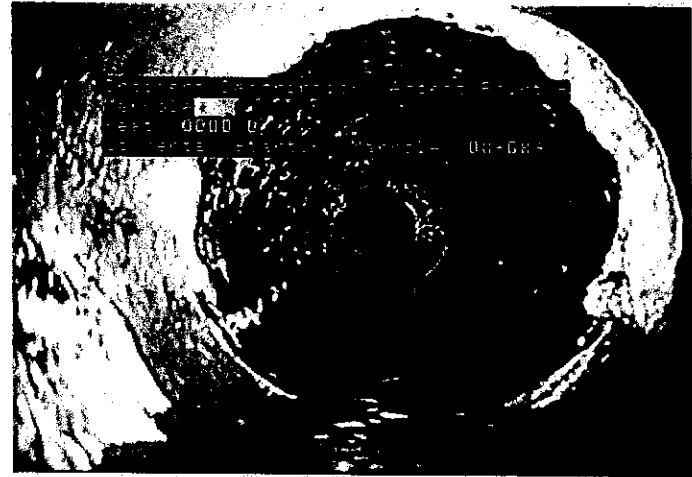
MWL - Water Level @ 0.0 ft.

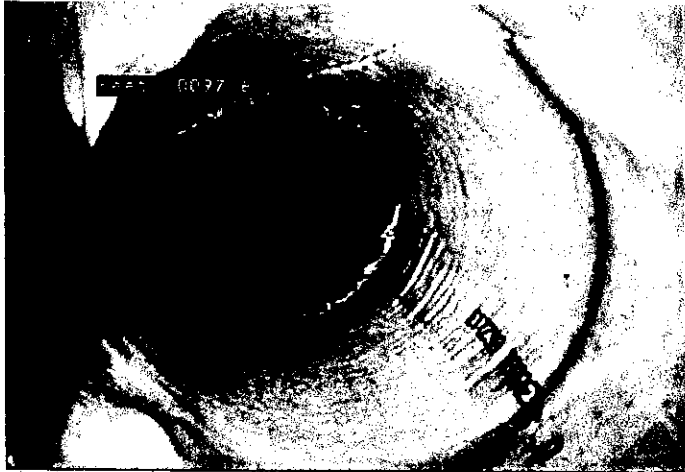
TFA - Tap, Factory Made: Active @ 97.6 ft.  
liner looks good, house 1021

97.6' [TFA] Tap, Factory Made: Active 9 liner looks good, house 1021
